DEPARTMENT OF NATURAL RESOURCES
DIVISION OF OIL, GAS AND MINING

RE: Site Inspections, Gemstone Mining Incorporated, Red Emerald Mine, M/001/045, Beaver County, Utah

Date of Inspection: 11/8/2001, 12/4/2001, 12/21/2001, and 1/8/2002 (BLM Inspection)
Time of Inspection: 9:00 a.m.-2:00 p.m.
Conditions: Cold and cloudy
Participants: Clint Christiansen, Construction and Mining Services (CMS), and Dominique Merz, President of GMI; Ed Ginouves, BLM; and Tom Munson, DOGM

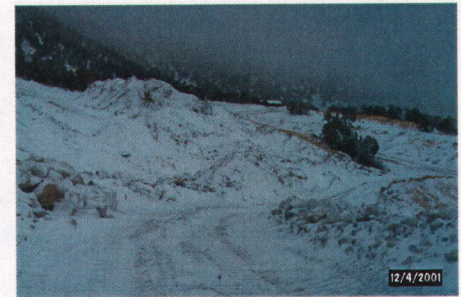
P0003013.JPG
12/04/1901

MOVING MATERIAL
FROM BACKSIDE TO FRONT
OF UPPER PIT

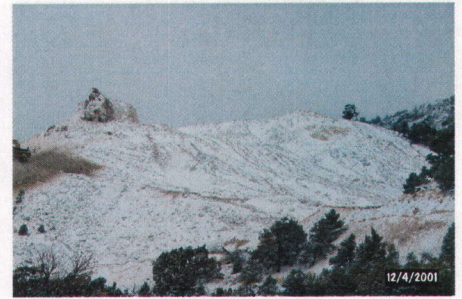
P0002998.JPG
12/04/1901

UPPER PIT

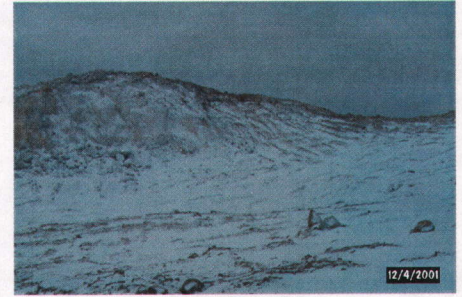
P0003001.JPG
12/04/1901

UPPER PIT REGRAVING
